Recommended Practices for Improving Cyclonic Resistance of Dwellings/Low-rise Buildings

CSIR – Structural Engineering Research Centre
(Council of Scientific and Industrial Research)
CSIR Campus, Taramani
Chennai 600 113

National Disaster Management Authority
NDMA Bhawan
A-1 Safdarjung Enclave
New Delhi 110 029

RECOMMENDED PRACTICES FOR IMPROVING CYCLONIC RESISTANCE OF DWELLINGS/LOW-RISE BUILDINGS

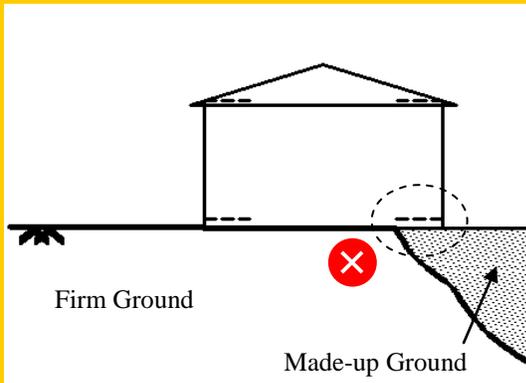
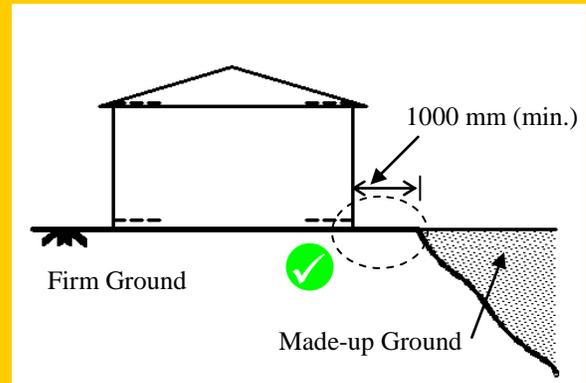
- ❖ The entire foundation of a house should be constructed on the same soil and not on made-up-soil.

Undesirable ❌

Preferred ✅

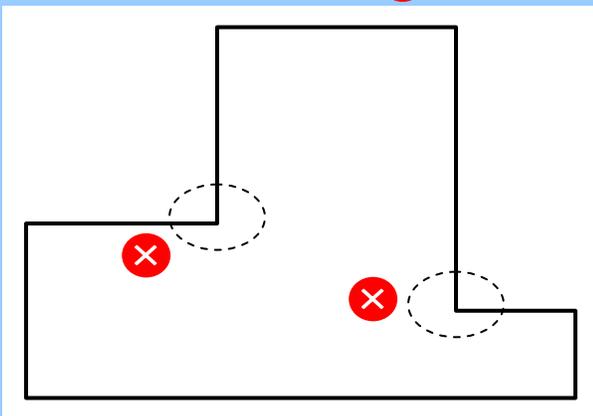
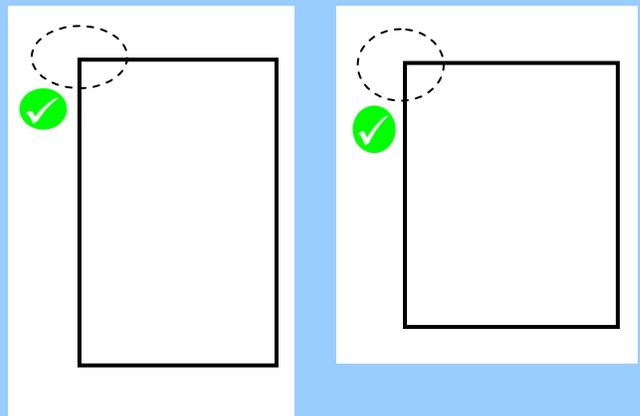
- ❖ Projections resulting in reentrant corners should be avoided to the extent possible
- ❖ Closed configuration, viz. square/ rectangle, is preferred for house plans.

Undesirable ❌

Preferred ✅

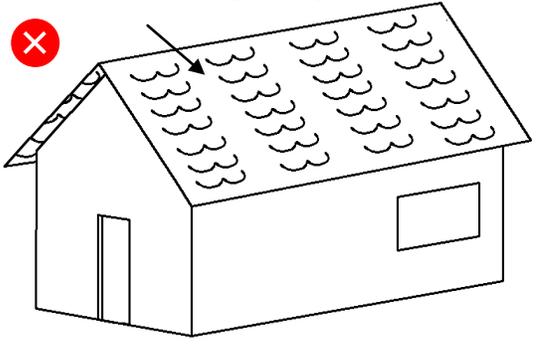
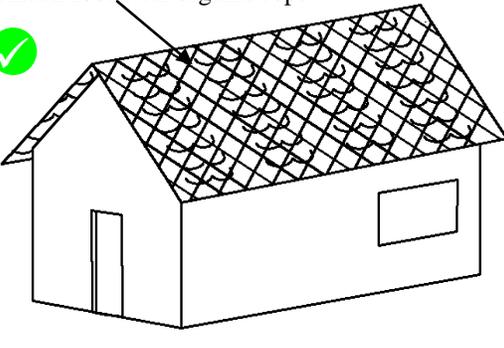
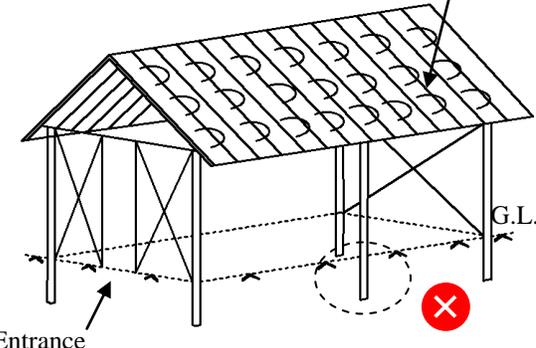
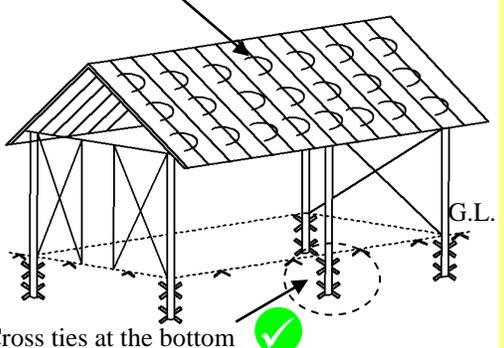
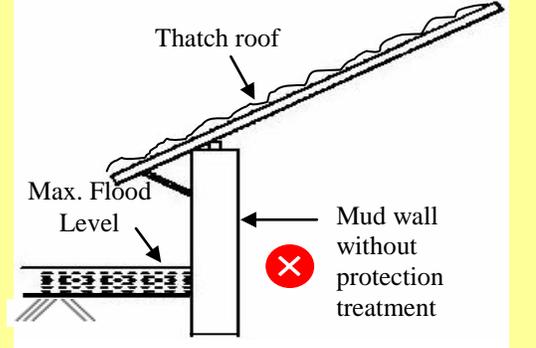
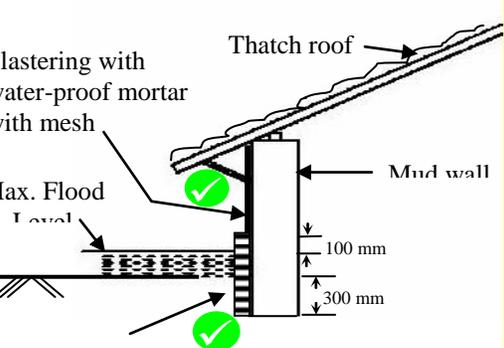
❖ Improvement for thatch roofs and mud walls to reduce damages due to cyclones

Undesirable ❌	Preferred ✅
<p>Thatch roof without organic rope</p>

<p>Thatch roof with organic rope</p>

<p>Thatch roof</p>

<p>Entrance</p> <p>G.L.</p>	<p>Thatch roof</p>

<p>Cross ties at the bottom</p> <p>G.L.</p>
<p>Thatch roof</p>

<p>Max. Flood Level</p> <p>Mud wall without protection treatment</p>	<p>Thatch roof</p>

<p>Plastering with water-proof mortar with mesh</p> <p>Max. Flood Level</p> <p>Mud wall</p> <p>100 mm</p> <p>300 mm</p> <p>Protective barrier or revetment built with stone or brick</p> <p>Not to scale</p>

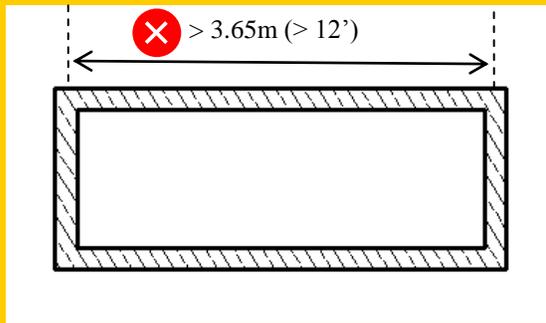
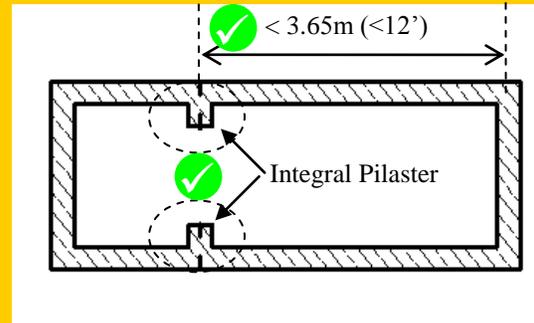
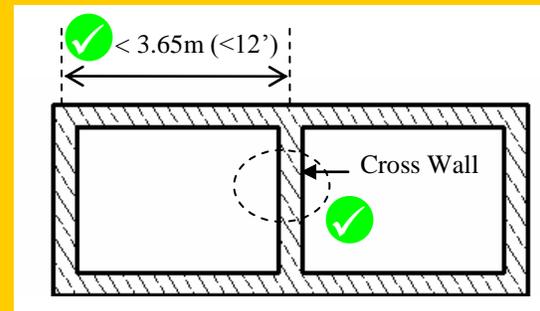
- ❖ In case of rectangular plan, the length of an individual wall should be kept less than 3.65 m (12') which can be achieved by provision of intervening cross walls or pilasters.

Undesirable ❌

Preferred ✅

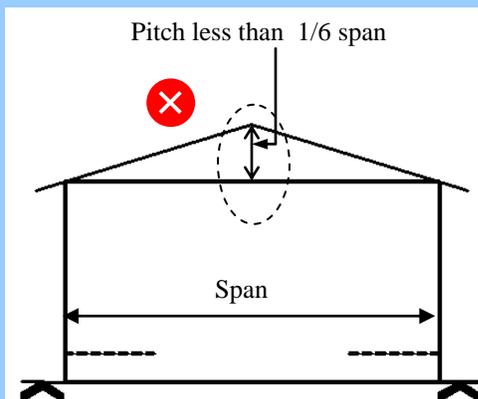
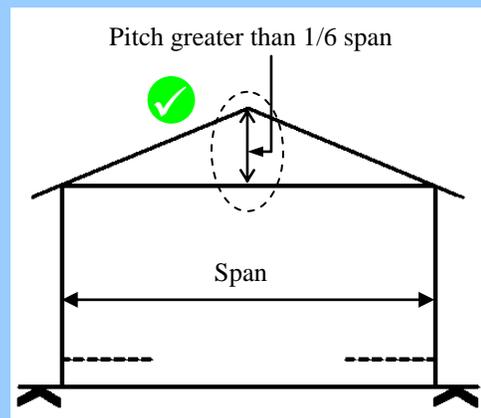
- ❖ Low pitches for roofs should be avoided

Undesirable ❌

Preferred ✅

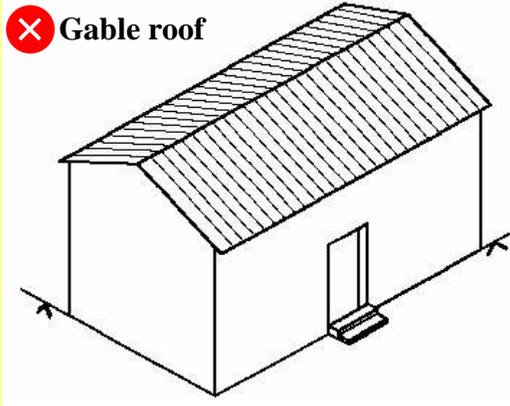
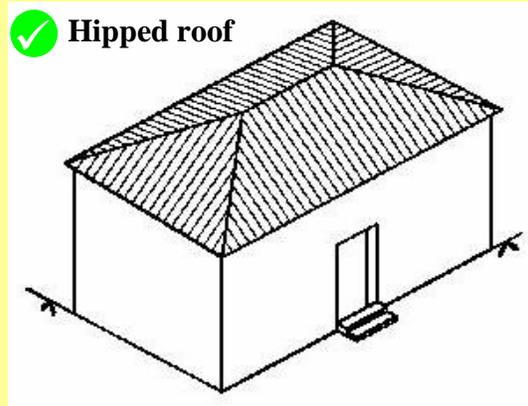
❖ Hipped roofs are preferable to gable roofs.

Undesirable ❌

Preferred ✅

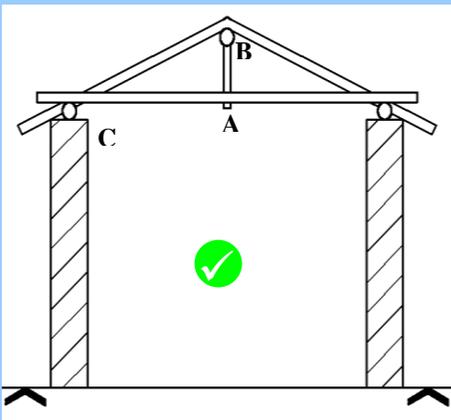
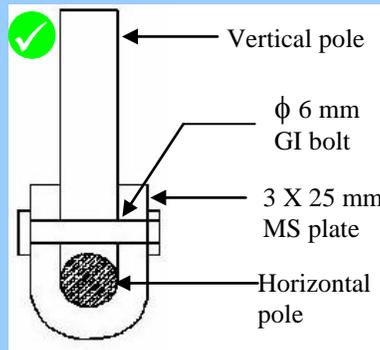
JOINT - A (side view)

❖ Joints with retrofitting measures (for use in thatch roof dwellings)

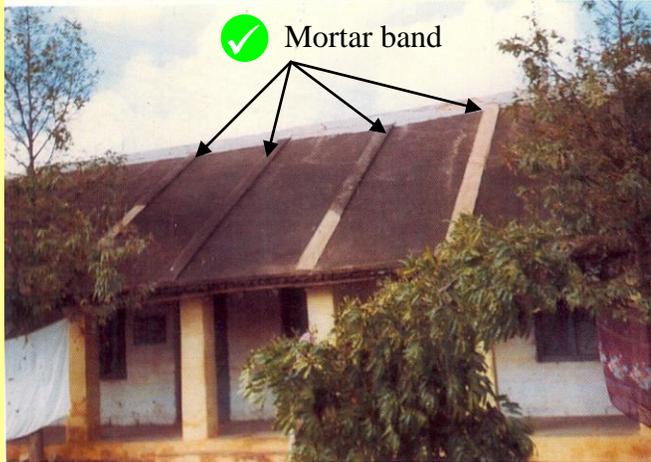
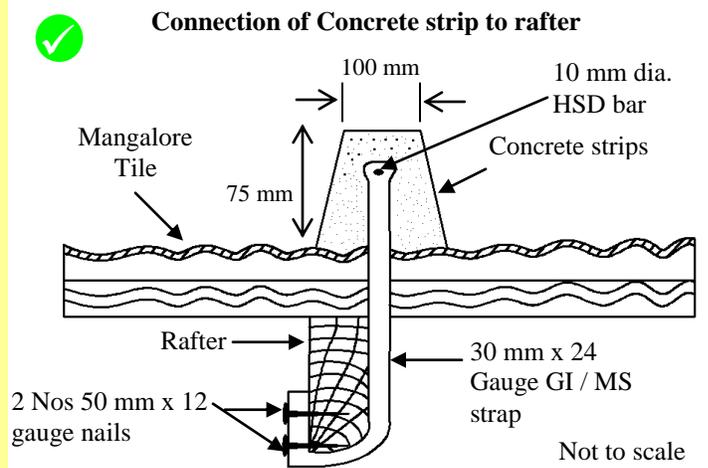
- ❖ Remedial measure by providing mortar bands / concrete strips for tiled roofs

Improvement to tiled roofs to reduce damage to roof due to cyclones

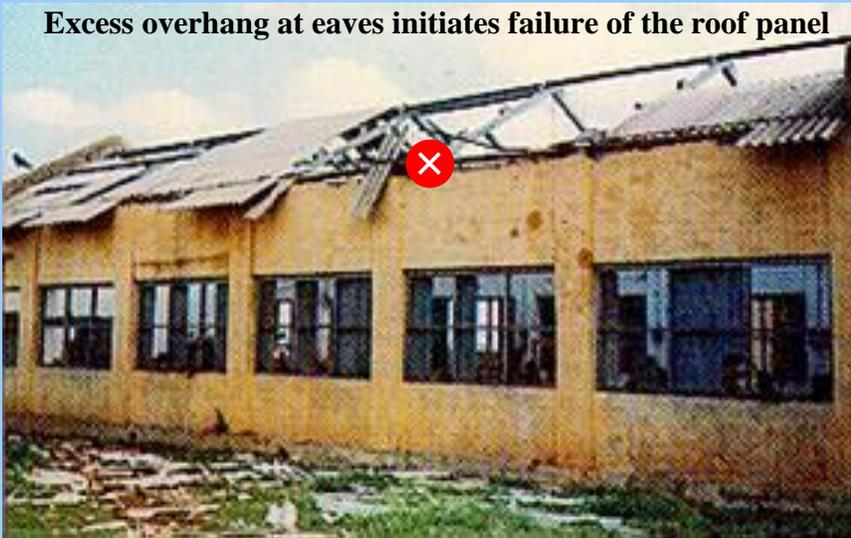
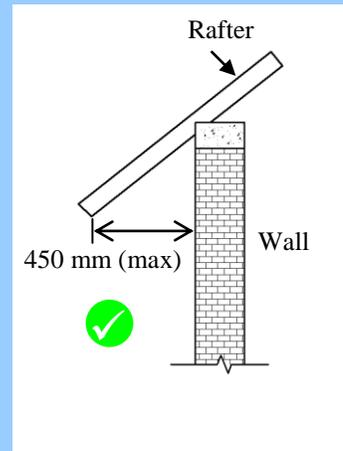
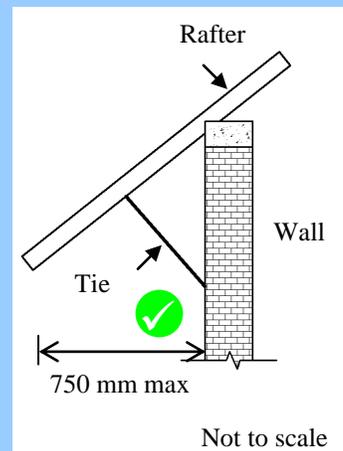
- ❖ The overhang at eaves shall not exceed 450 mm. In case it exceeds this value, the projected portion of the roof may be properly tied back to the wall frame work

Excess overhang at eaves initiates failure of the roof panel

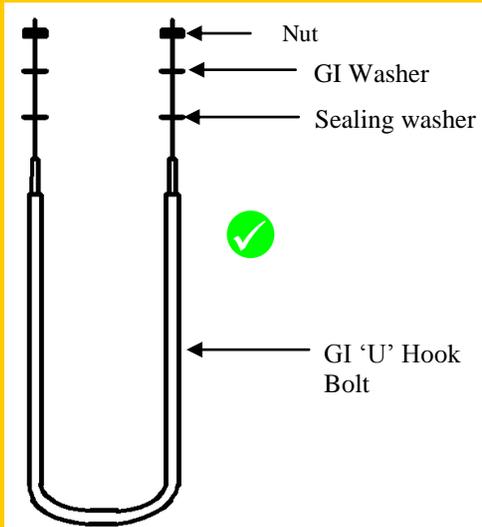
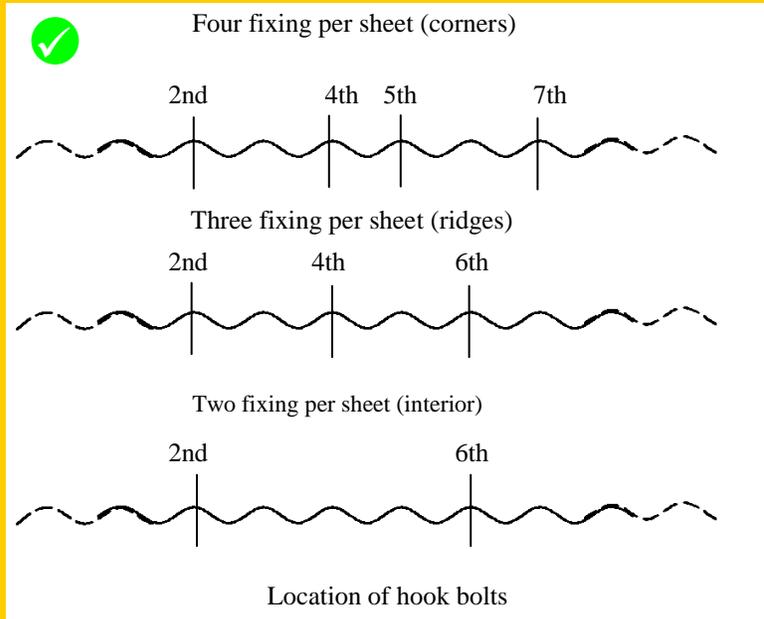
- ❖ Use “U”-bolt and washer assembly in place of conventional ‘J’-bolt connections between cladding and the purlins. Provide additional numbers of ‘U’-bolts at ridges and eaves compared to interior region

Detailing of U-bolts for roof cladding sheets

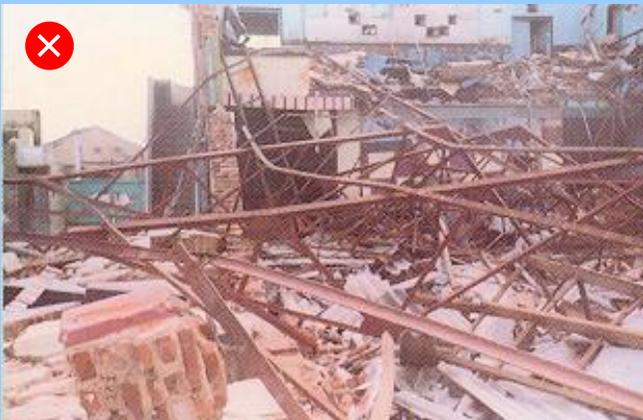
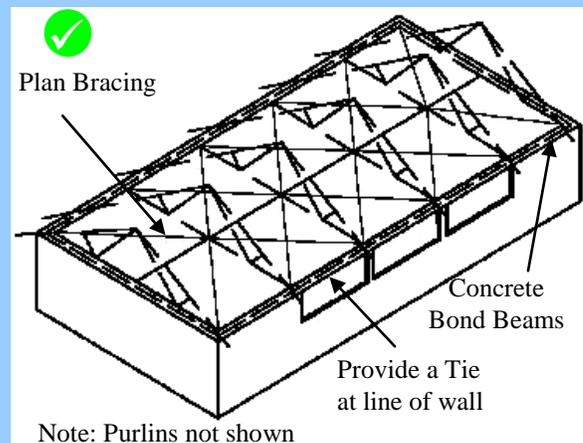
- ❖ Provide Plan bracing at the bottom chord level of trusses to avoid bottom chord buckling due to uplift force as well as to distribute the horizontal loading from gable ends
- ❖ Upper chord bracing is also to be provided (not shown in figure) near gable end walls
- ❖ Provide a continuous R.C.C bond beam over the walls to improve the lateral resistance of the supporting brick walls

Provision of Wind bracing for Roof Trusses to improve Strength and Stability

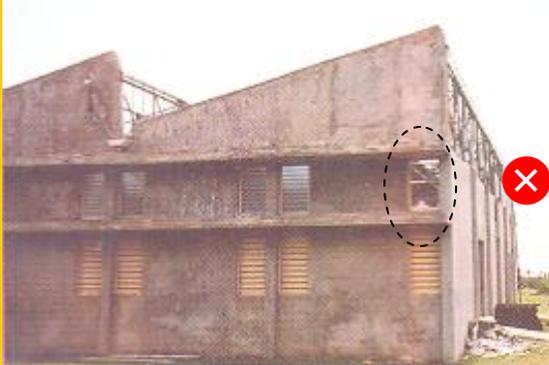
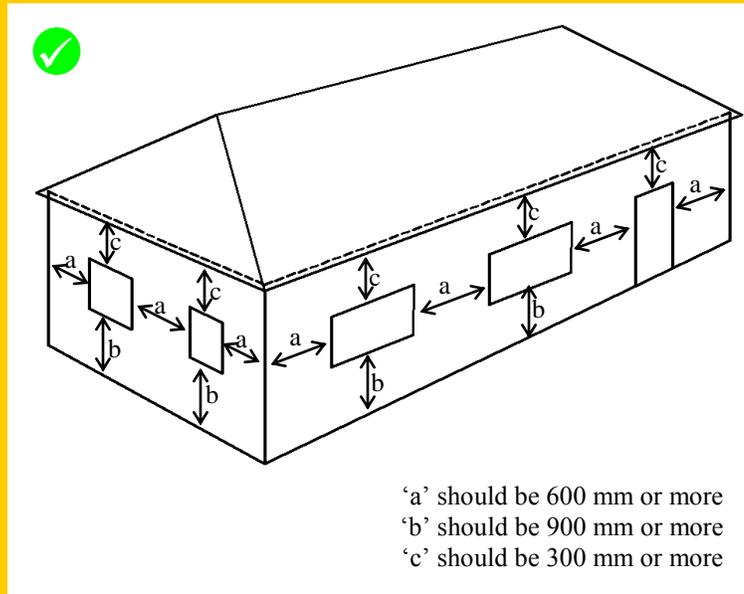
- ❖ The opening near to the edge of a wall should be positioned with a minimum distance as shown

Minimum Distances between Openings in the Wall

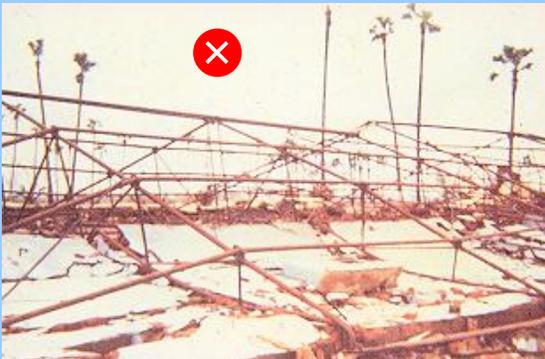
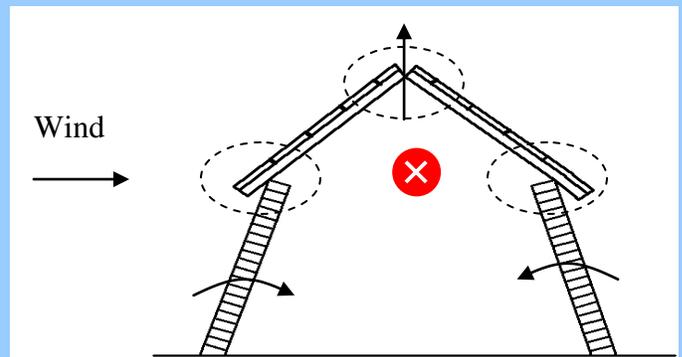
- ❖ Many low-rise industrial buildings collapse due to failure of brick masonry walls. In order to improve their resistance to wind loading, the masonry walls may be strengthened by embedding reinforcement with sufficient rich mortar cover to prevent corrosion. The figures below show complete collapse of the masonry walls.

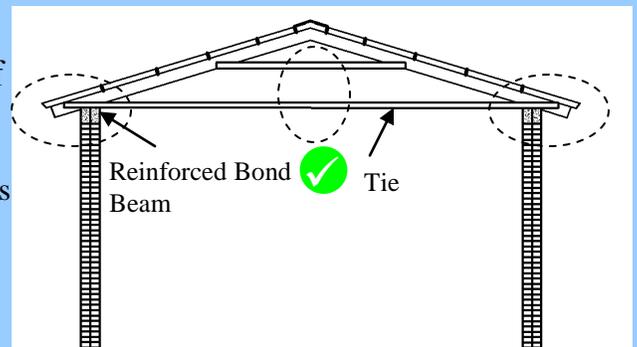
Suggested remedial measure – provision of

- (i) reinforcement in the wall,
- (ii) proper connection between roof and side walls
- (iii) ties in the roof truss

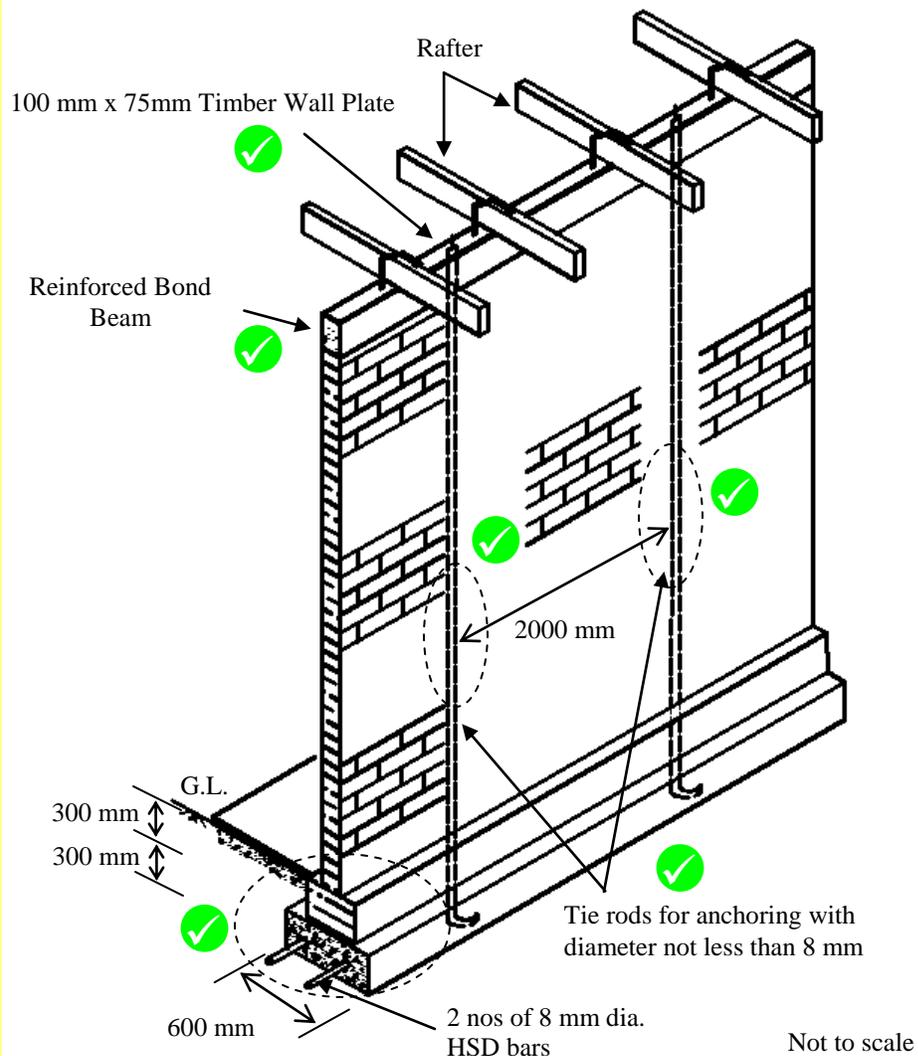
The continuity of the load path from the roof to the foundation in case of hollow concrete block masonry as shown below is essential.

**Connecting roof to the foundation using Tie-down bolts
(typical for a dwelling with plinth area of 15 sq. m (approx))**

The main reason for the failure of masonry walls due to cyclonic winds is due to the lack of adequate lateral restraint. The masonry must be capable of resisting the lateral load acting both in-plane and out-of-plane in addition to carrying the vertical loads. The masonry must also be capable of resisting impact loads from wind-borne debris.
